DAMAGE ASSESSMENT FORM

Building Name THE DAN ROBERTS HOUSE
Address 18240 S.W. 248 street (COCONUT PALM DRIVE)
City (or Vicinity) and County Dade County REDLAND
Owner (Mrs. EARSIE DELCHAMPS.)

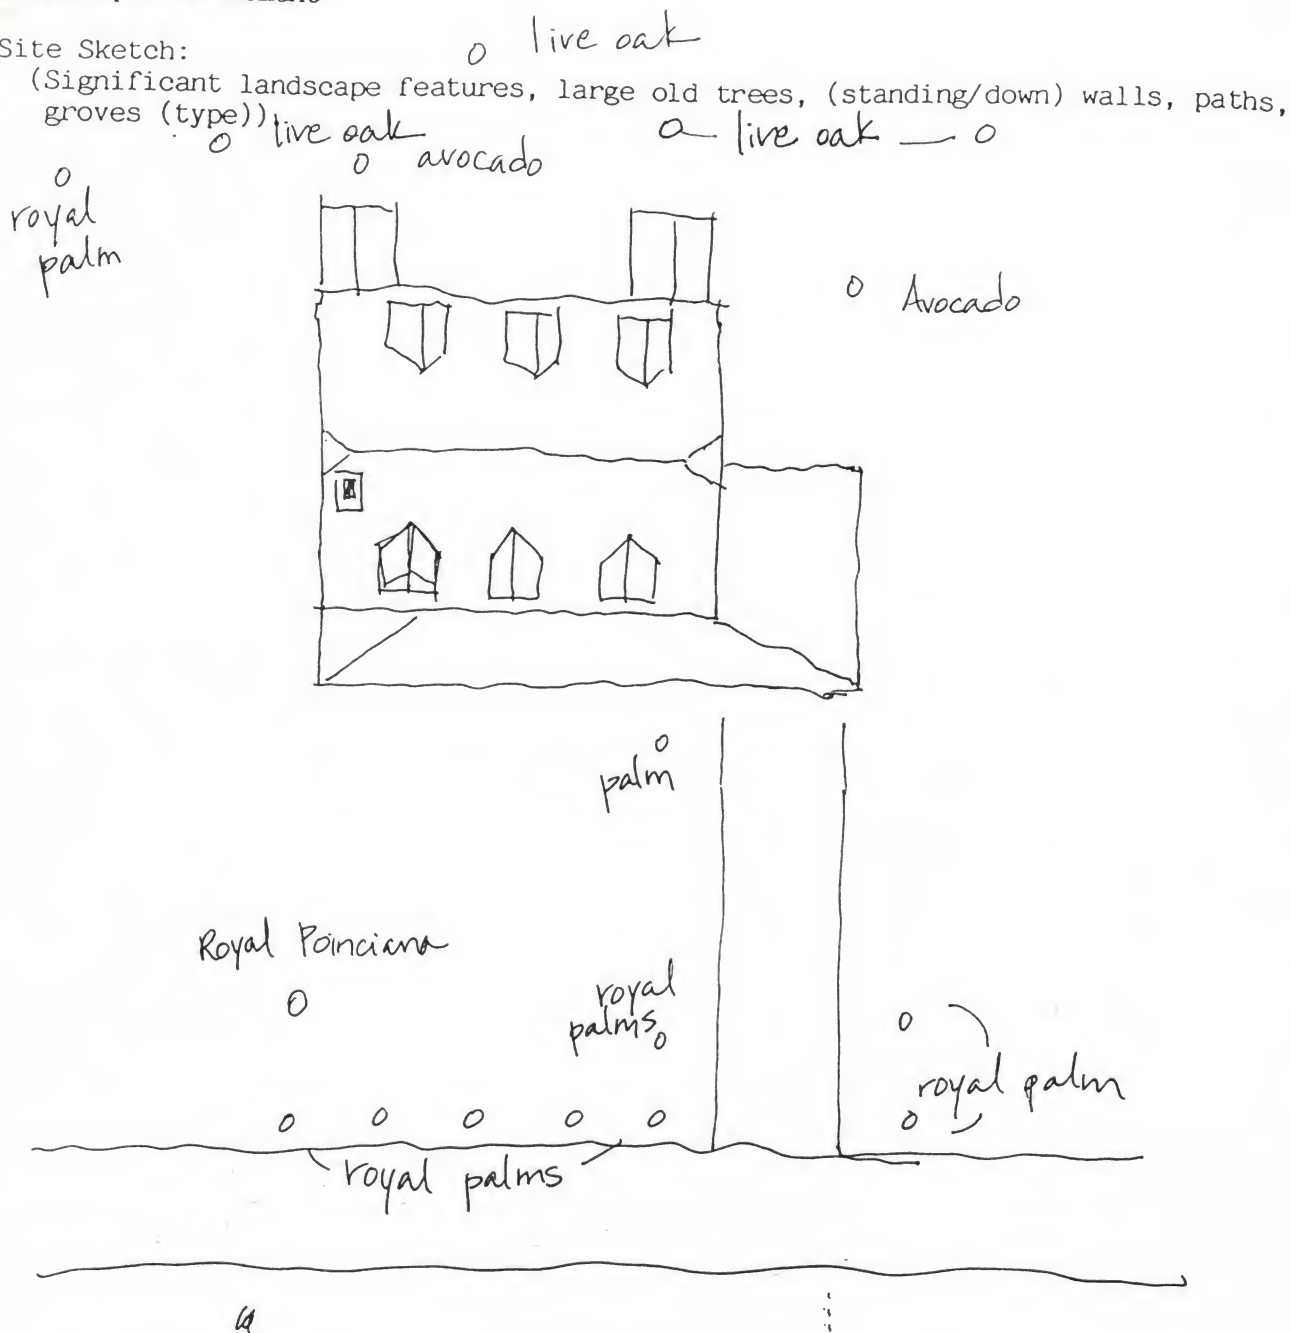
Site Sketch:

- 4 royal palms down
- avocado tree uprooted
- most trees still standing, just lost limbs
